# Curly-leaf Pondweed Post-treatment Inspection Report

Lake: North and South Lake Lida

Inspection Date: 06/18/2026

Report Author: Hannah Passolt, MS, CMWP

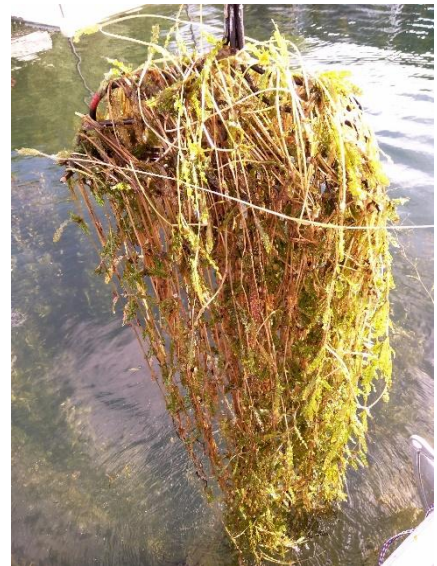
**Figure 1.** Thrown rake sample with curly-leaf pondweed.

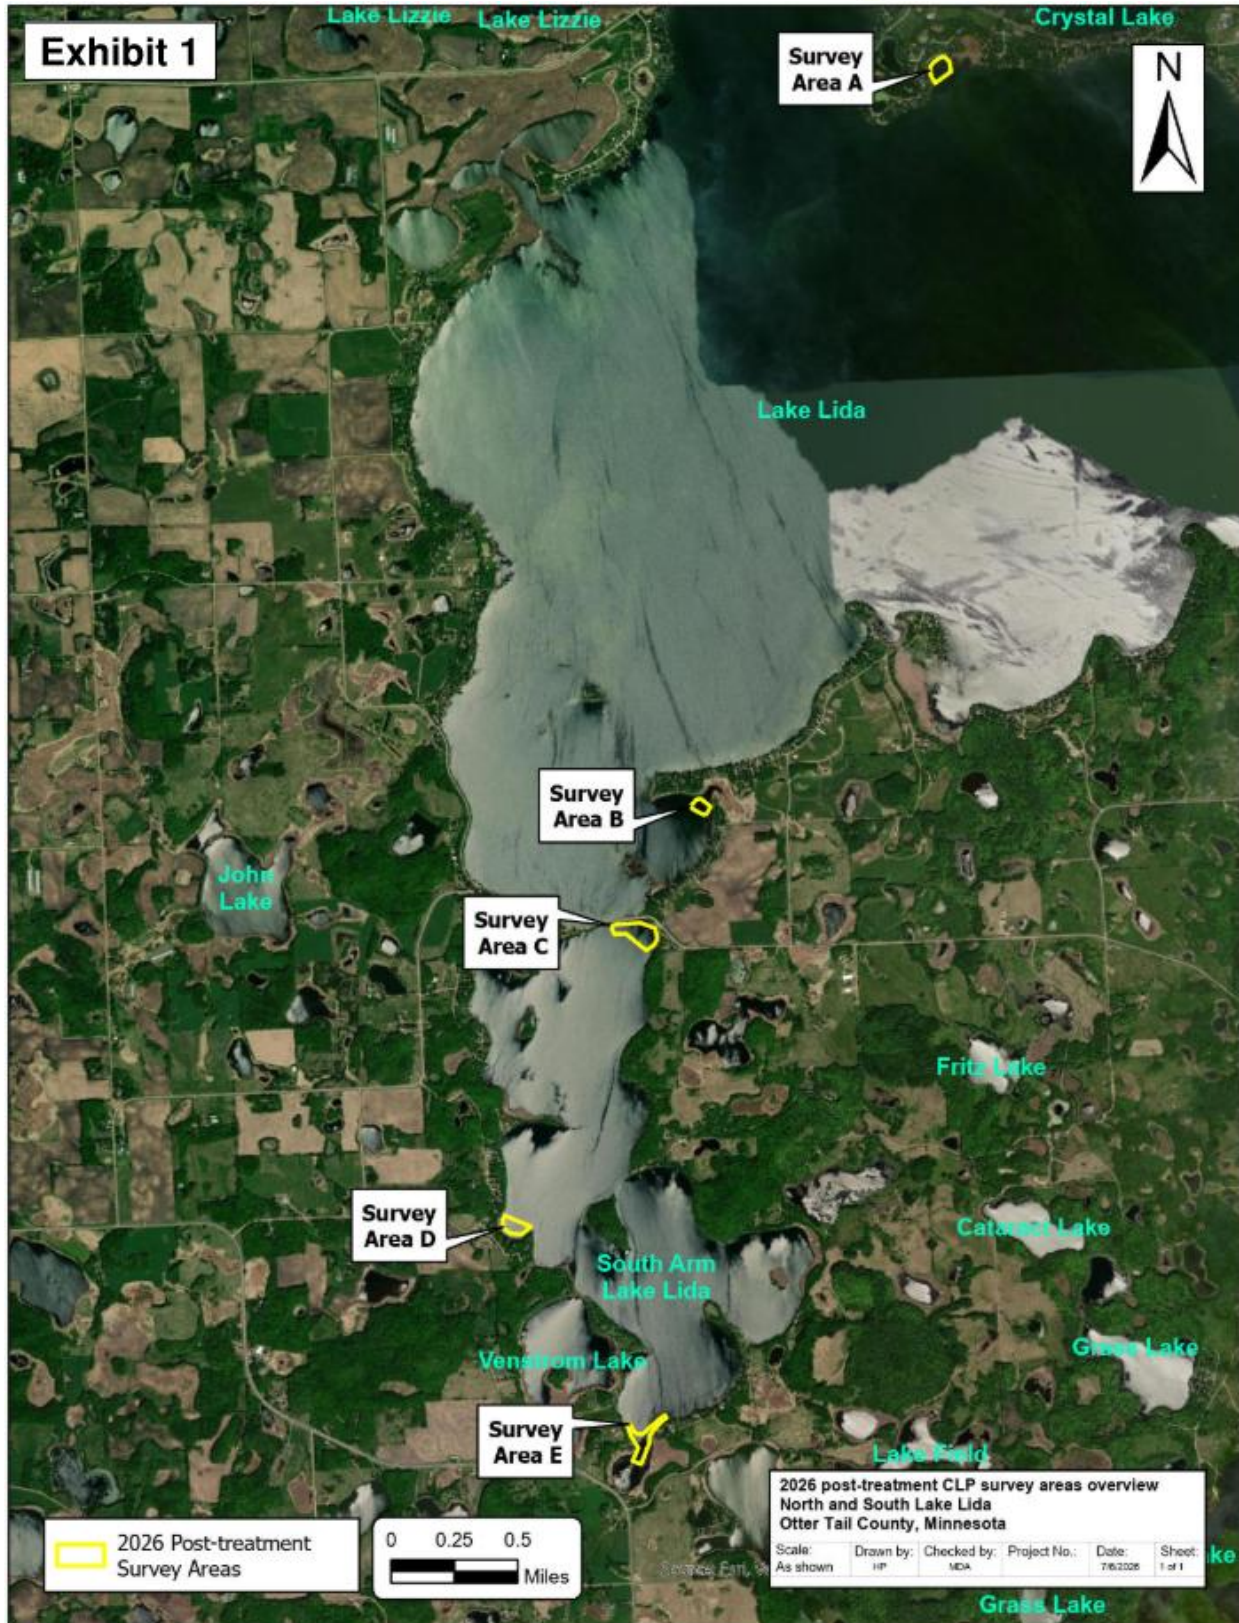
# **Exhibit 1**

A total of five survey areas were sampled on North Lida and South Lida (**Exhibit 1**). Survey area A is a new curly-leaf infestation identified in 2026 (no herbicide treatment applied in 2026). Survey areas B, C, D and E all received herbicide treatments in 2026.

## **2026 Survey Areas Overview Map**

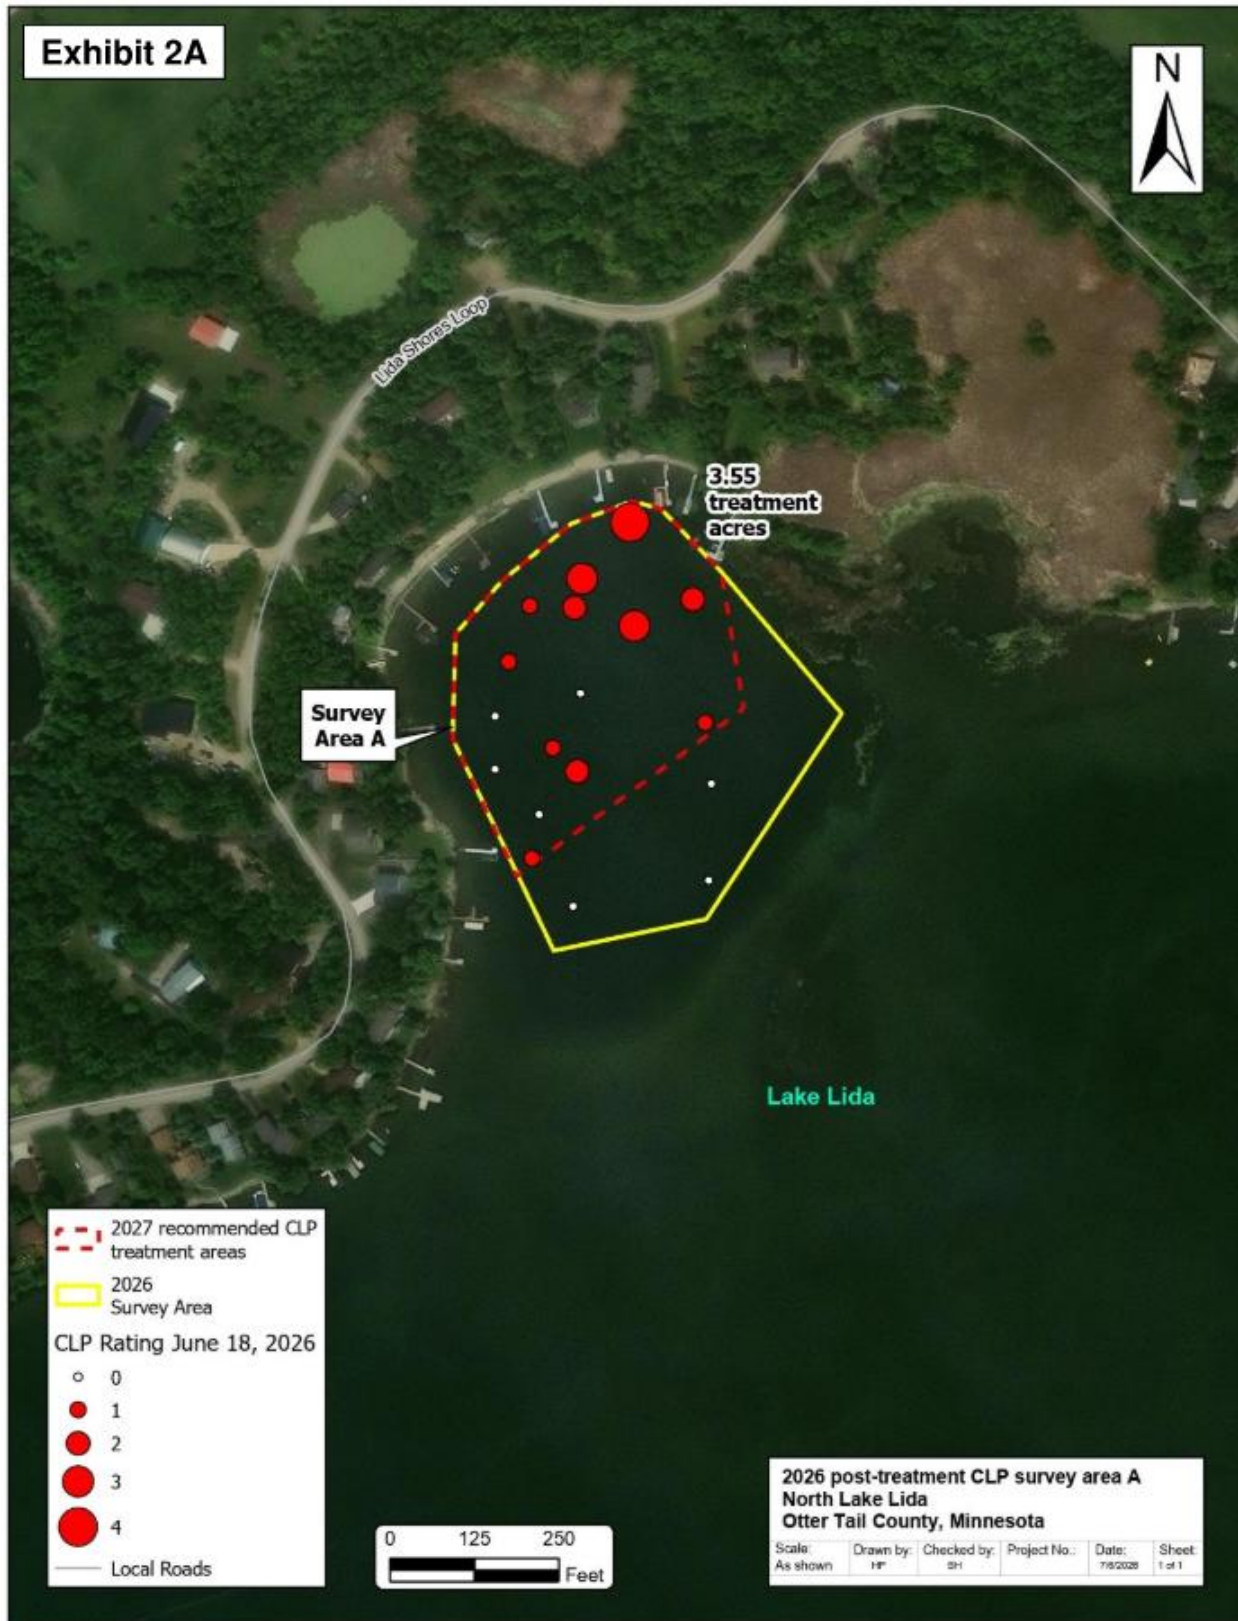
**Exhibit 2A**

Two survey areas (total 7.68 acres) were sampled in North Lake Lida. CLP was present in both survey areas (**Table 1, Exhibit 2A and 2B**).

| Lake | Map ID | Average density rating | Survey area acres | # sample points | # CLP observations |
|---|---|---|---|---|---|
| North Lida | A | 1.17 | 5.76 | 18 | 11 |

Survey area A was not treated with herbicide in 2026, and CLP abundance was relatively high. Survey areas B, C, D, and E were treated with herbicide in 2026. While CLP abundance was reduced in most treatment areas when compared to 2025, there are portions of survey areas B and E with relatively high abundance of CLP. Herbicide treatments were more effective in survey areas C and D, where frequency of CLP observations and abundance ratings were very low.

Herbicide treatments are recommended for survey areas A, B, and E. No herbicide treatment is recommended for survey areas C and D. Recommended treatment areas are summarized in **Table 3** and shown on **Exhibits 2A, 2b, and 2E**.

| Lake | Survey area Map ID | Recommended 2027 Treatment Acres |
|---|---|---|
| North Lida | A (new survey area) | 3.55 |

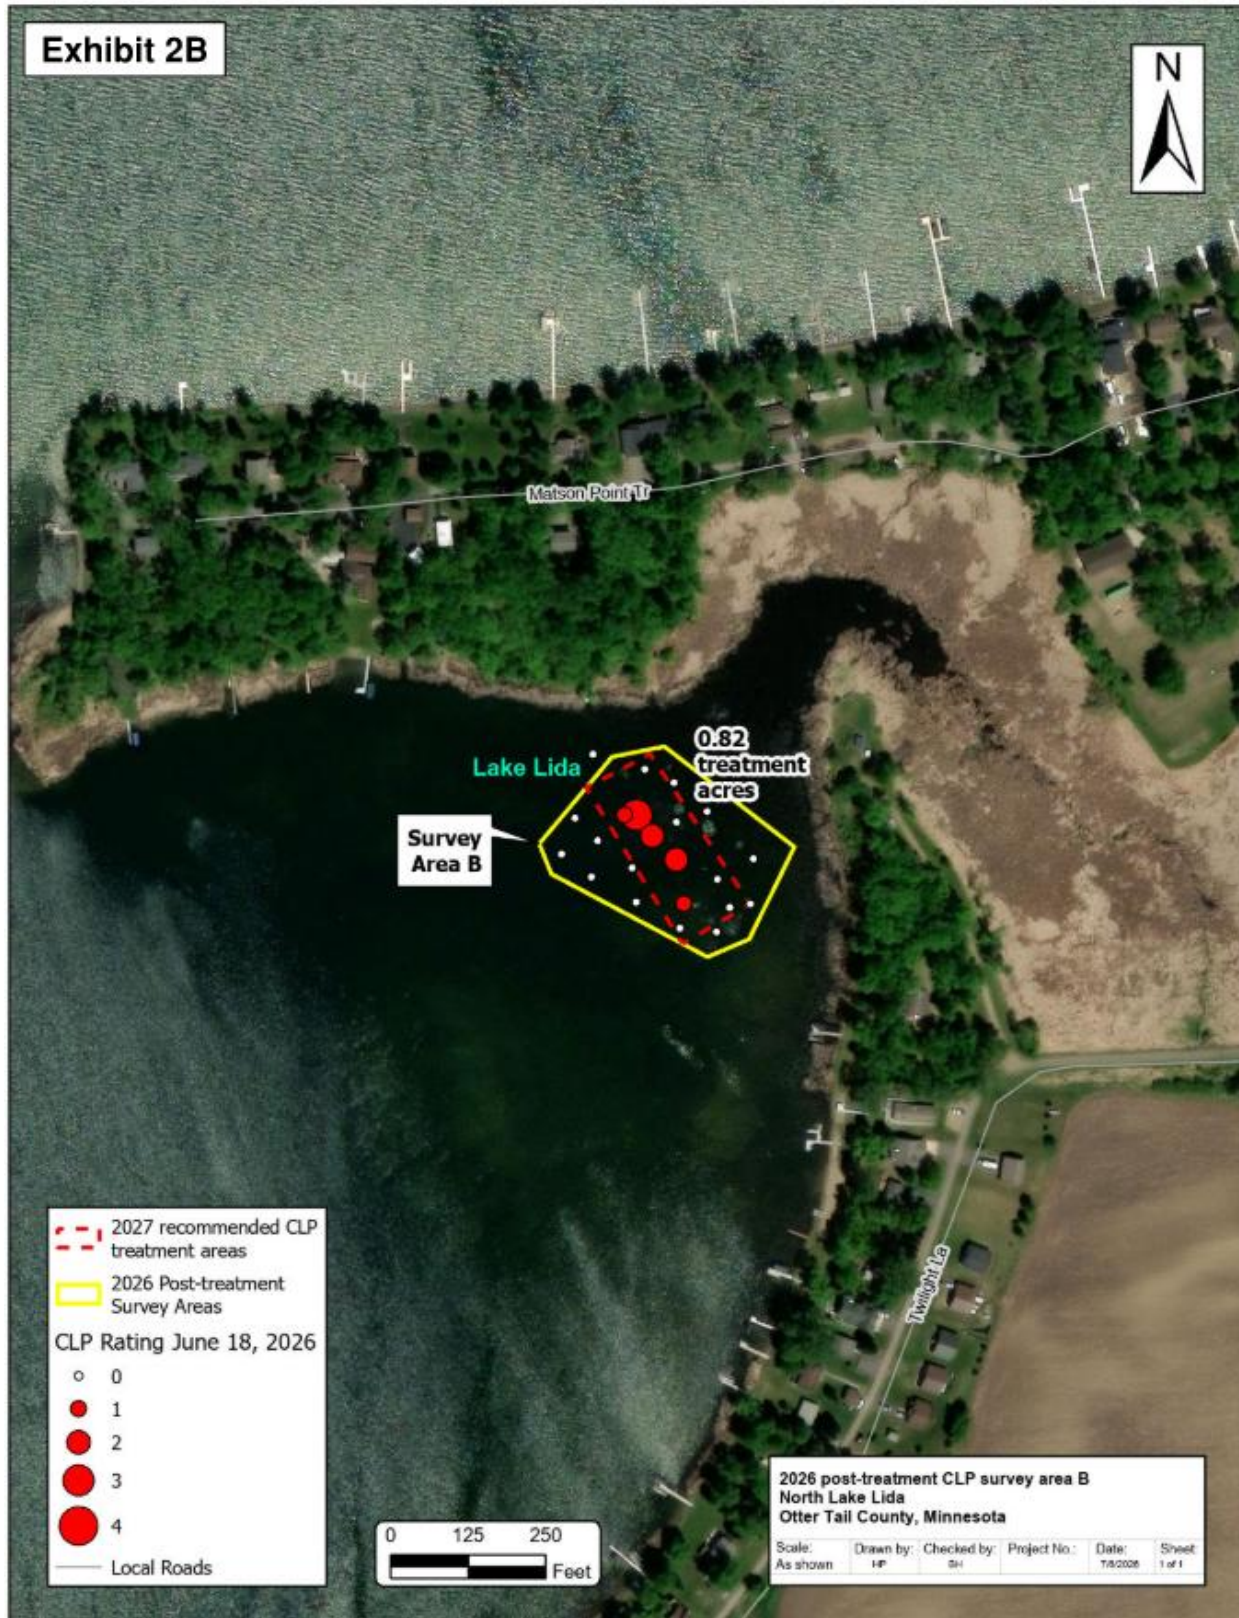
| Lake | Map ID | Average density rating | Survey area acres | # sample points | # CLP observations |
|---|---|---|---|---|---|
| | B | 0.41 | 1.92 | 22 | 5 |

| Lake | Survey area Map ID | Recommended 2027 Treatment Acres |
|---|---|---|
| | B | 0.82 |

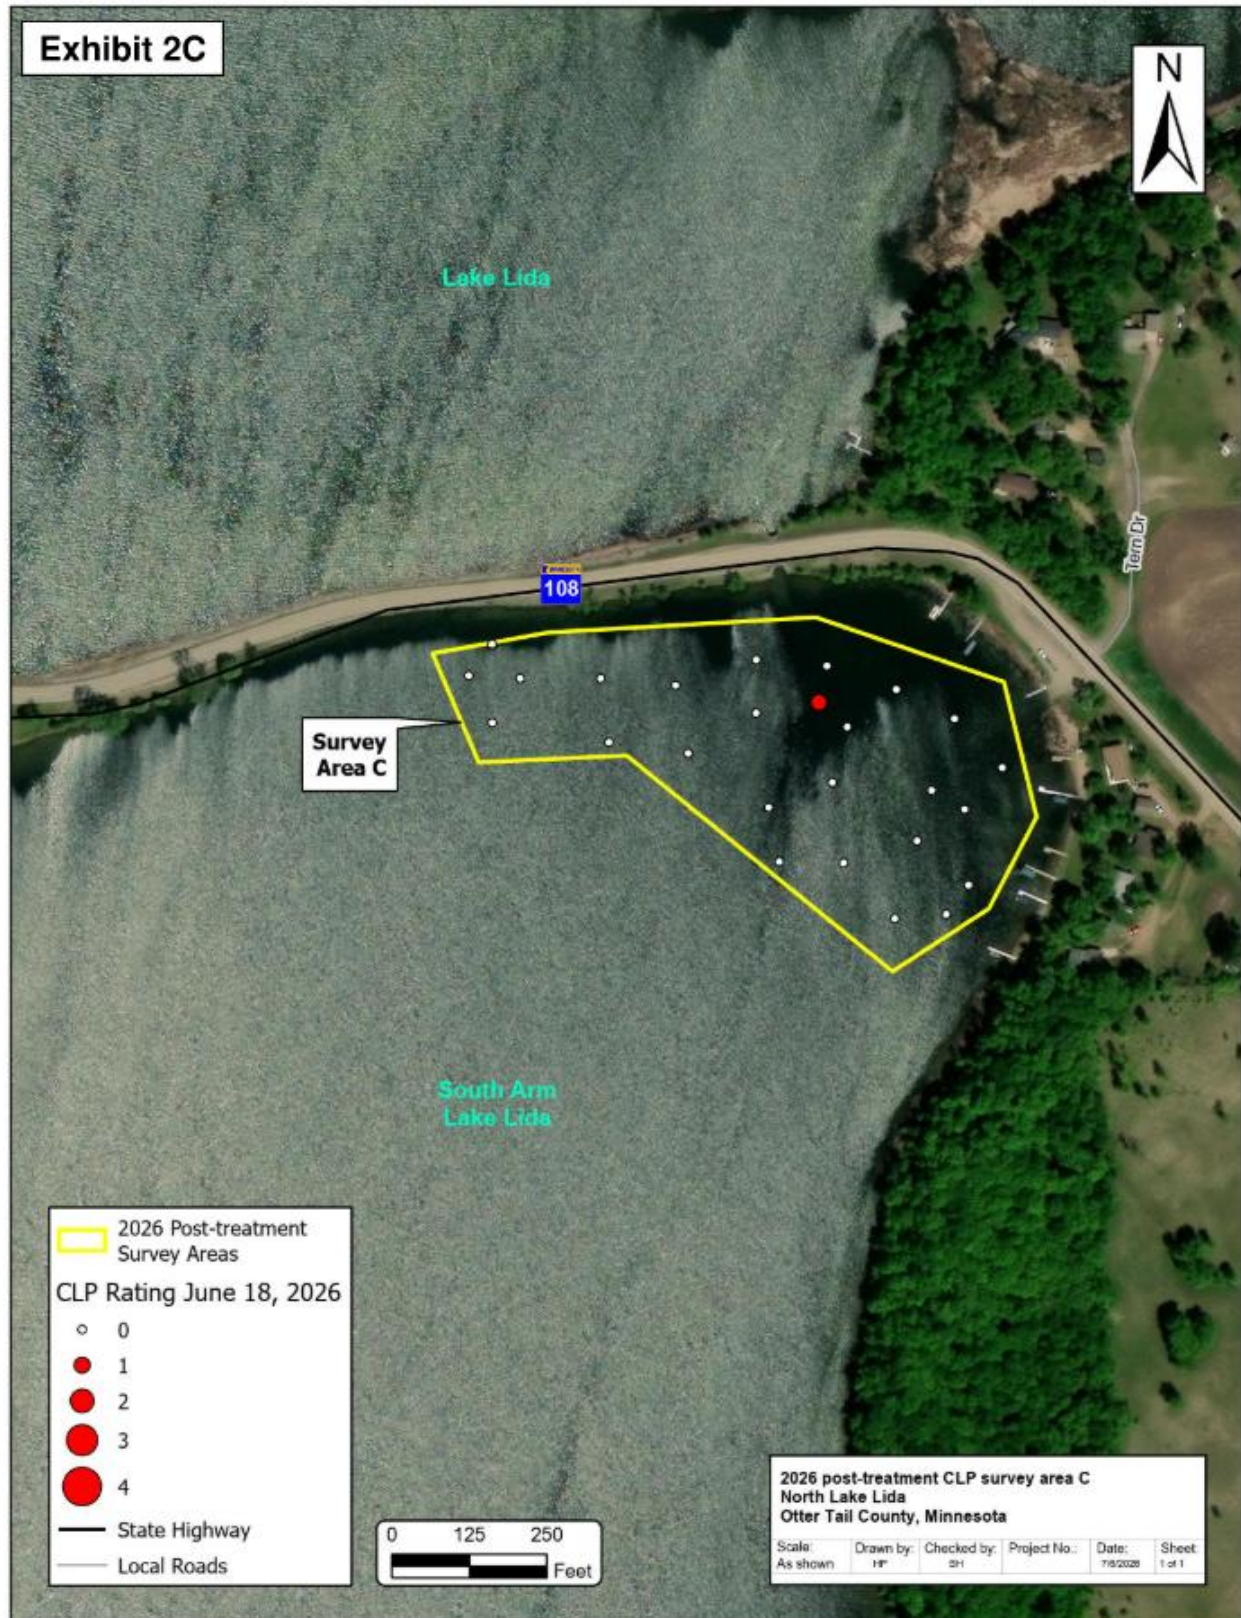
Three survey areas were sampled in South Lake Lida (**Exhibits 2C-2E**). CLP was present in two of the three survey areas (**Table 2**). Survey Area E had the highest average density rating of 2.24 (**Figures 2a and 2b**).

| Lake | Map ID | Average density rating | Survey area acres | # Sample points | # CLP observations |
|---|---|---|---|---|---|
| South Lida | C | 0.04 | 7.06 | 26 | 1 |

| Lake | Survey area Map ID | Recommended 2027 Treatment Acres |
|---|---|---|
| South Lida | C | No treatment |

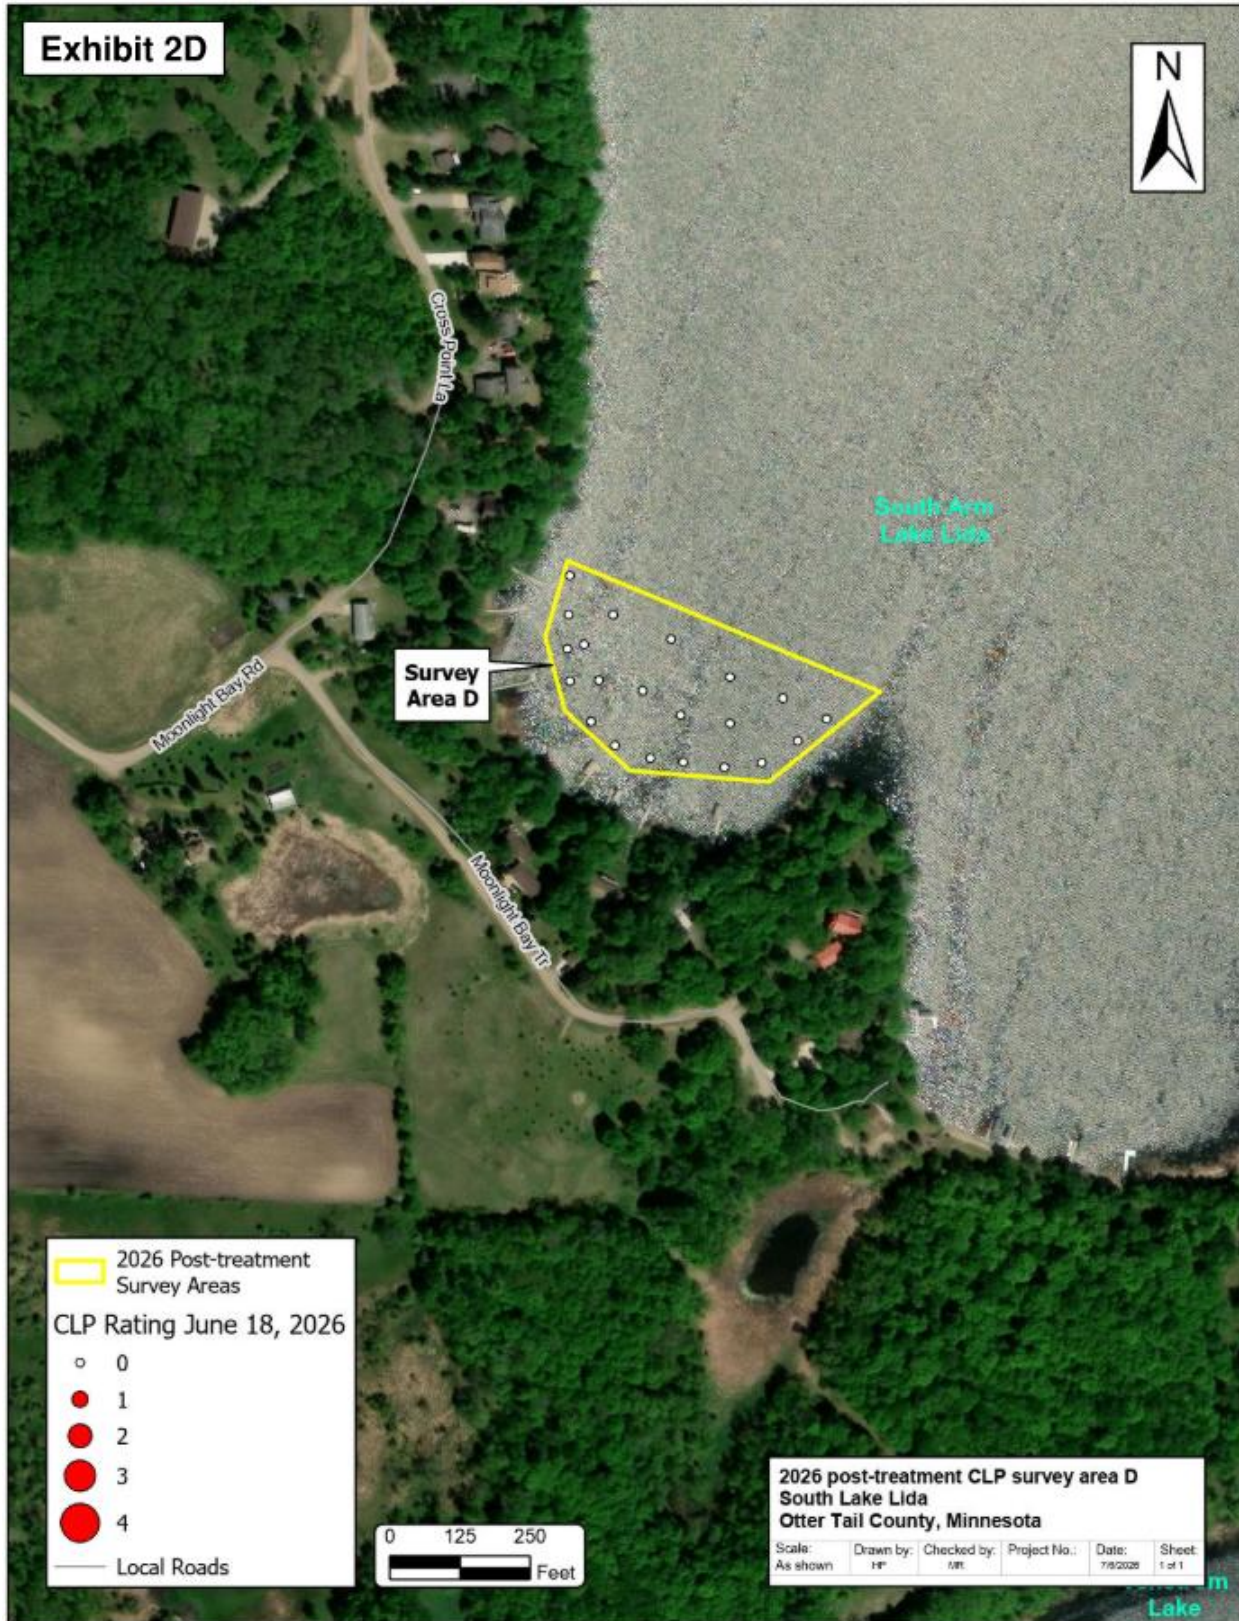
| Lake | Map ID | Average density rating | Survey area acres | # Sample points | # CLP observations |
|---|---|---|---|---|---|
| | D | 0.00 | 3.07 | 21 | 0 |

| Lake | Survey area Map ID | Recommended 2027 Treatment Acres |
|---|---|---|
| | D | No treatment |

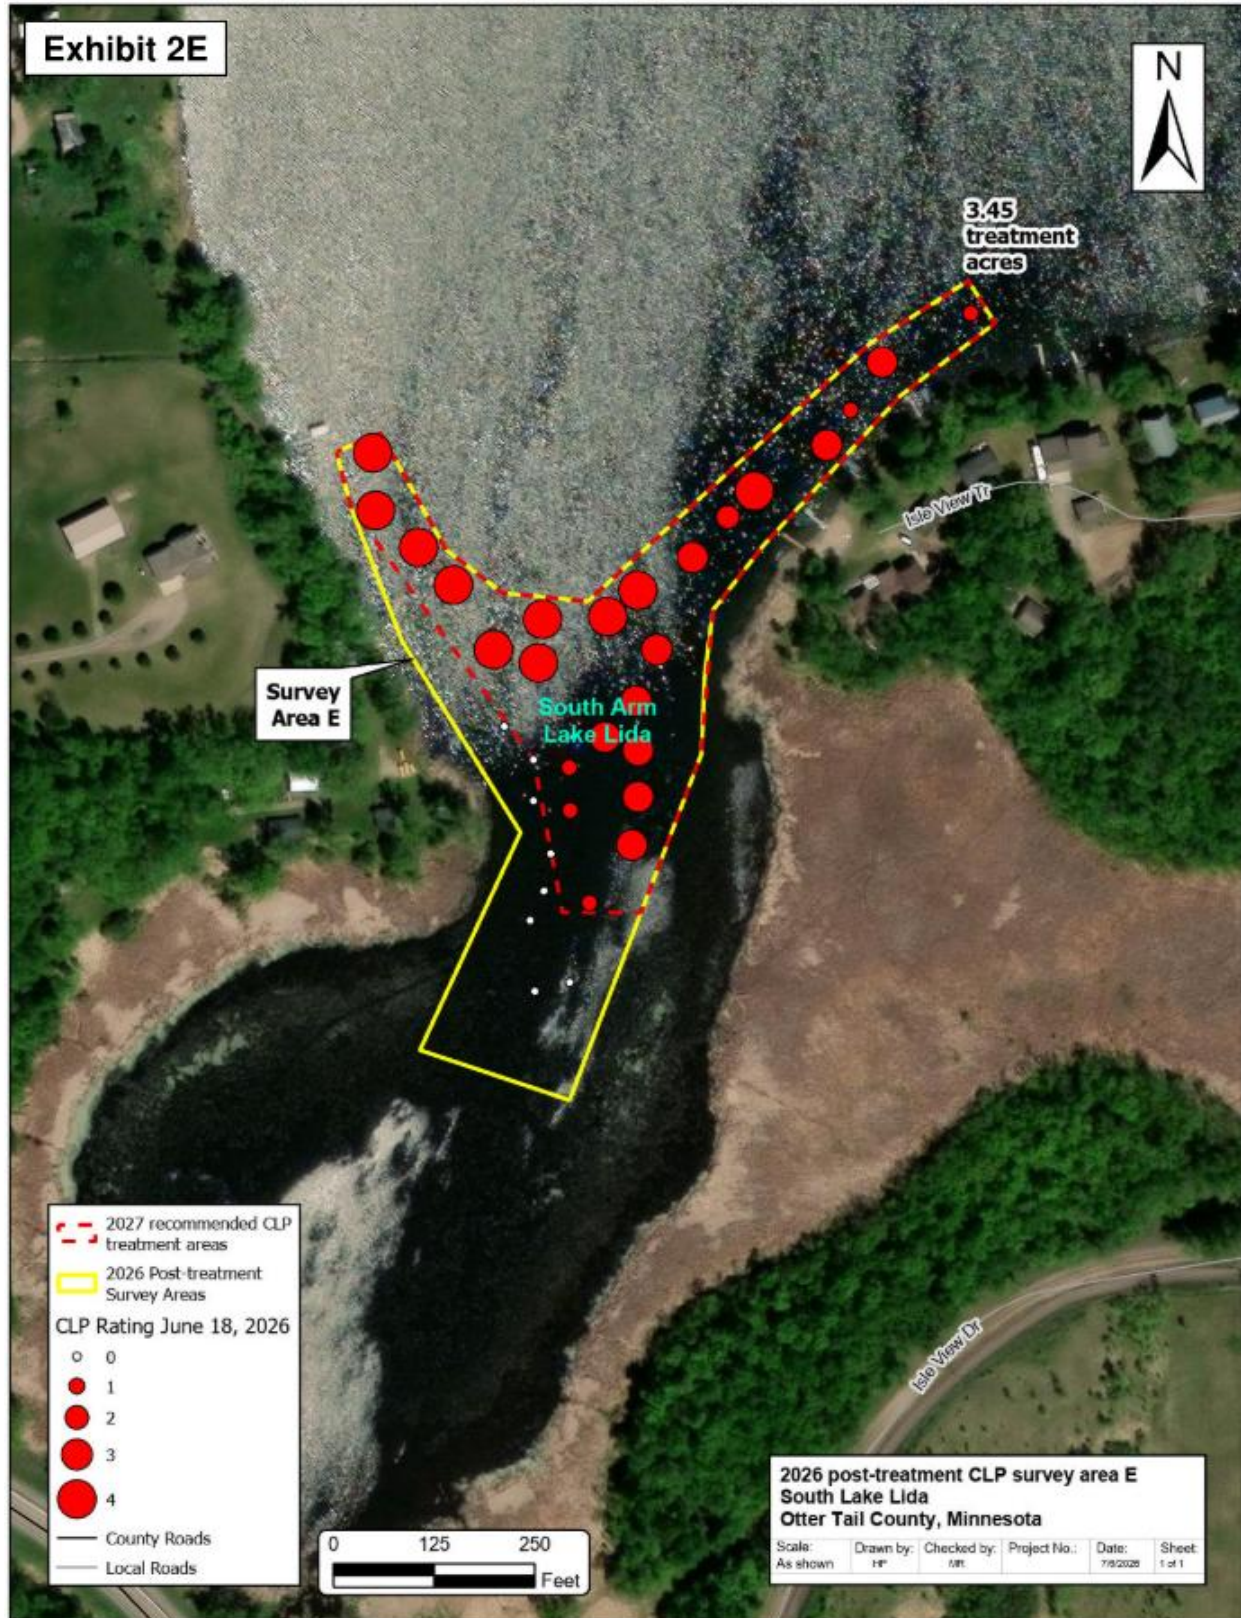
| Lake | Map ID | Average density rating | Survey area acres | # Sample points | # CLP observations |
|---|---|---|---|---|---|
| | E | 2.24 | 4.97 | 33 | 25 |

| Lake | Survey area Map ID | Recommended 2027 Treatment Acres |
|---|---|---|
| | E | 3.45 |
